HIGHWAY 33 AUTOPRO

Hwy 33 Autopro Level 1 Maintenance Inspection

Customer:	John Smith	License:	123 ABC
Vehicle:	2004 Honda CR-V	VIN:	JHLRD7745*****
Inspection date:	11/20/2017	Odometer:	in: 213,554- km
Repair Order #:		Technician:	Doug Hoy

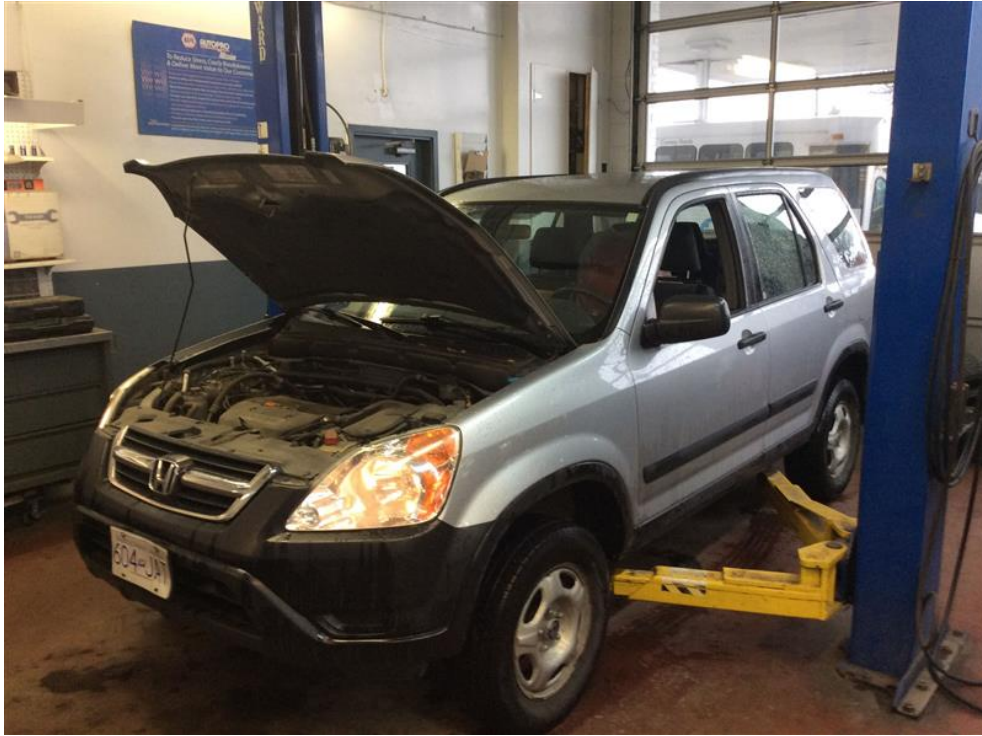
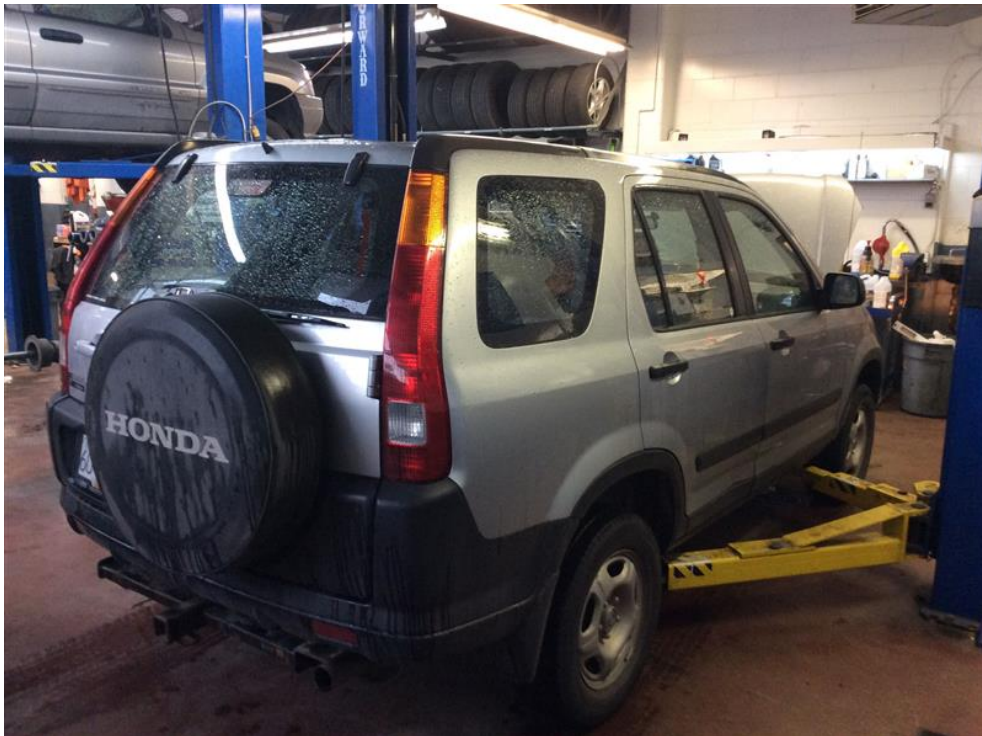
On the Floor	Observation	Action
Vehicle walk-around	Image(s): http://tinyurl.com/ycn39hep http://tinyurl.com/ya6q25wm <i>Right-hand mouse-click on link and select 'Open Link in New Tab'</i>	
Battery load test	200 amps @ 9.6 volts Image(s): http://tinyurl.com/y7qynuwd <i>Right-hand mouse-click on link and select 'Open Link in New Tab'</i>	
Coolant	Good to -40 deg C	
Brake fluid	Brake fluid - 1% moisture content - pass	
Washer fluid	Topped up - 1 jug	
On Hoist: Convenient height for wheel work	Observation	Action

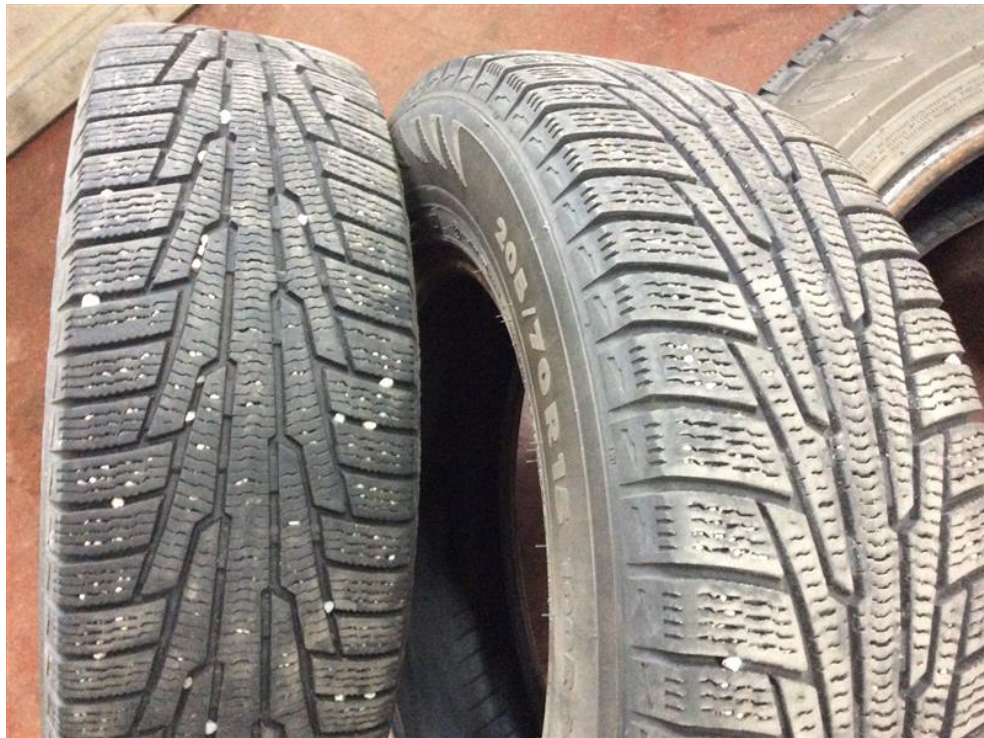
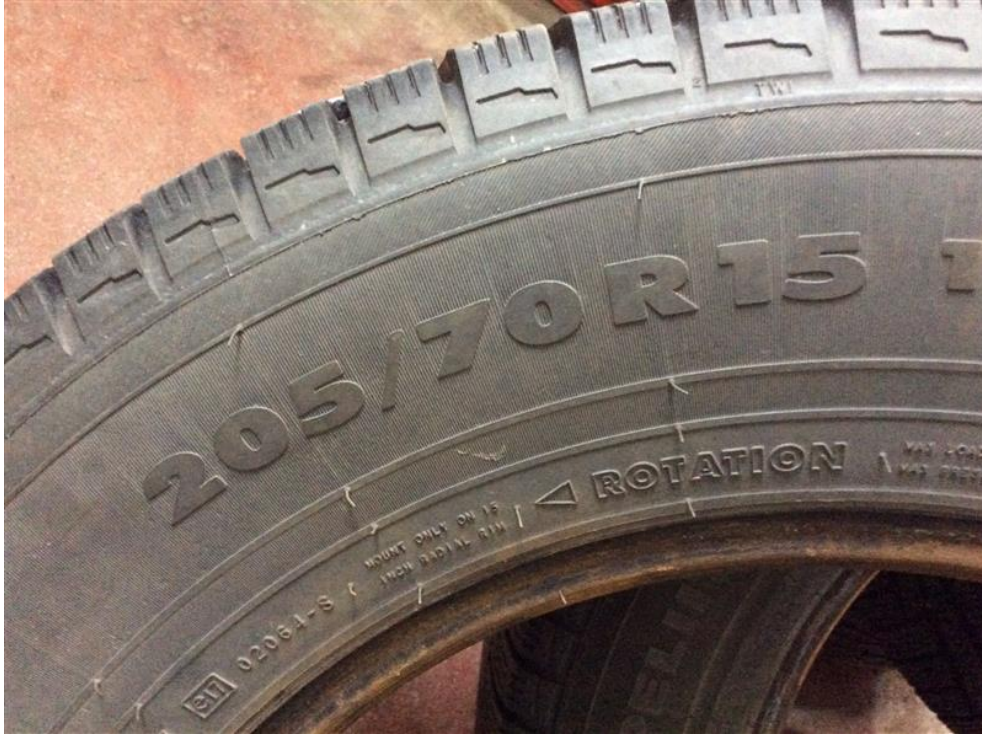
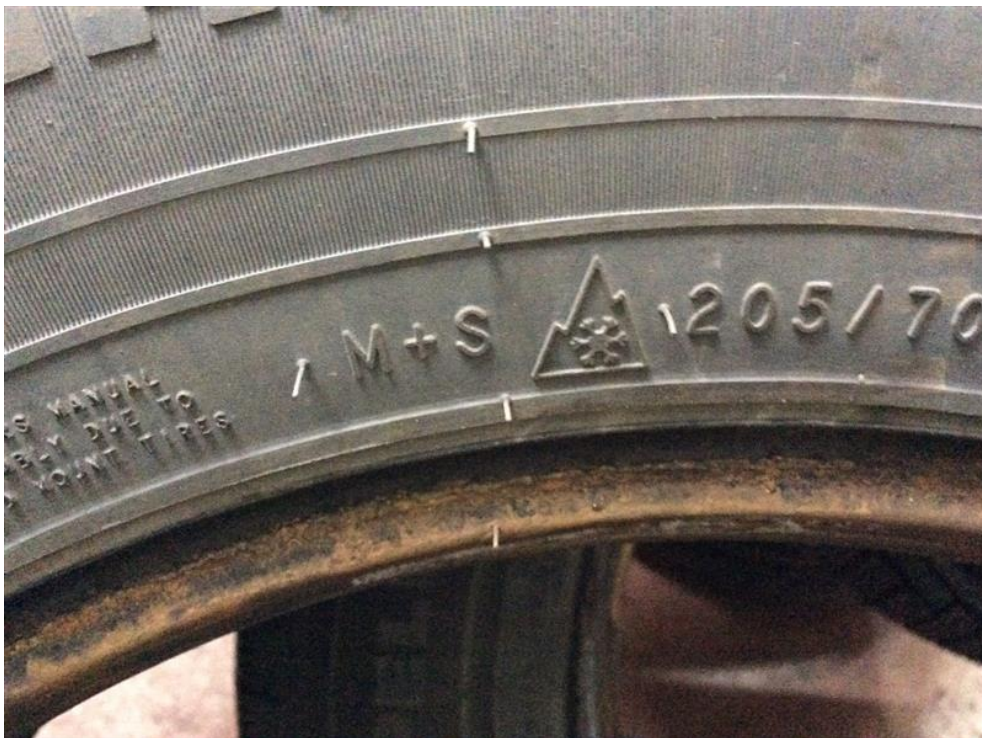
Winter Tire condition	Tread Depth - 9/32" <i>Image(s):</i> http://tinyurl.com/y86pe5dx http://tinyurl.com/y9sl82y2 http://tinyurl.com/y7j6capd <i>Right-hand mouse-click on link and select 'Open Link in New Tab'</i>	
Tire Pressure	34 PSI	
Front brake pads	Brake pads - 8 mm remaining <i>Image(s):</i> http://tinyurl.com/y9w2dskv http://tinyurl.com/y7mkz4ck <i>Right-hand mouse-click on link and select 'Open Link in New Tab'</i>	
Front brake rotors	<i>Image(s):</i> http://tinyurl.com/ybrqjcfp <i>Right-hand mouse-click on link and select 'Open Link in New Tab'</i>	
Rear brake pads	Brake pads - rear - 5MM <i>Image(s):</i> http://tinyurl.com/yab2hmoh <i>Right-hand mouse-click on link and select 'Open Link in New Tab'</i>	
Rear brake rotors	<i>Image(s):</i> http://tinyurl.com/ycdmyqq3 <i>Right-hand mouse-click on link and select 'Open Link in New Tab'</i>

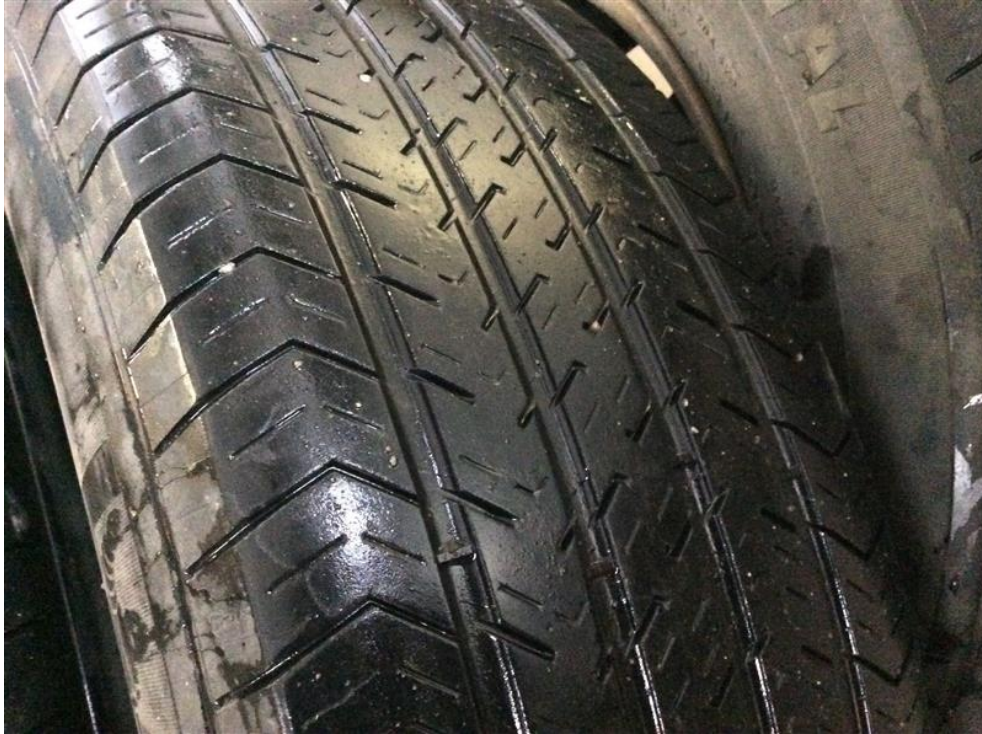
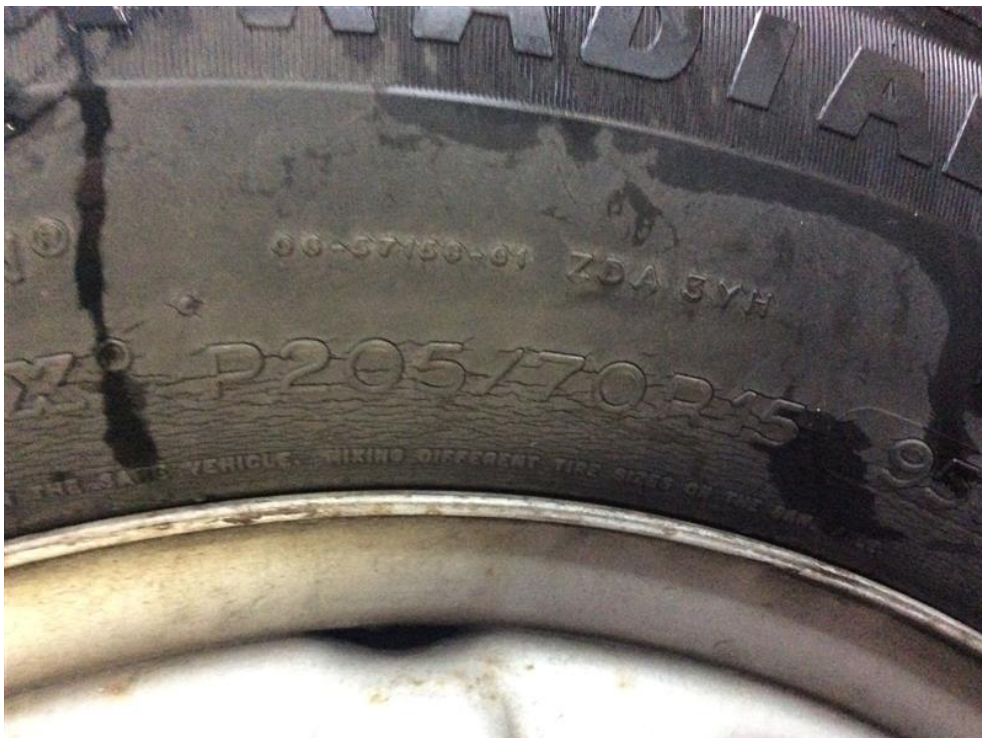
On Hoist: Convenient height for wheel work	Observation	Action
Summer / M&S Tire Condition	Tread Depth - 5/32" Marginal for next season <i>Image(s):</i> http://tinyurl.com/yaegngbd http://tinyurl.com/yb8v3v5e <i>Right-hand mouse-click on link and select 'Open Link in New Tab'</i>	
Rear Suspension components	Stabilizer bar end links Minor play in right rear end link <i>Image(s):</i> http://tinyurl.com/ybeyc8pw <i>Right-hand mouse-click on link and select 'Open Link in New Tab'</i>	Monitor
